**MaineDOT Fish Passage Policy and
Design Guide:
2004 Annual Report**

MaineDOT Fish Passage Steering Committee

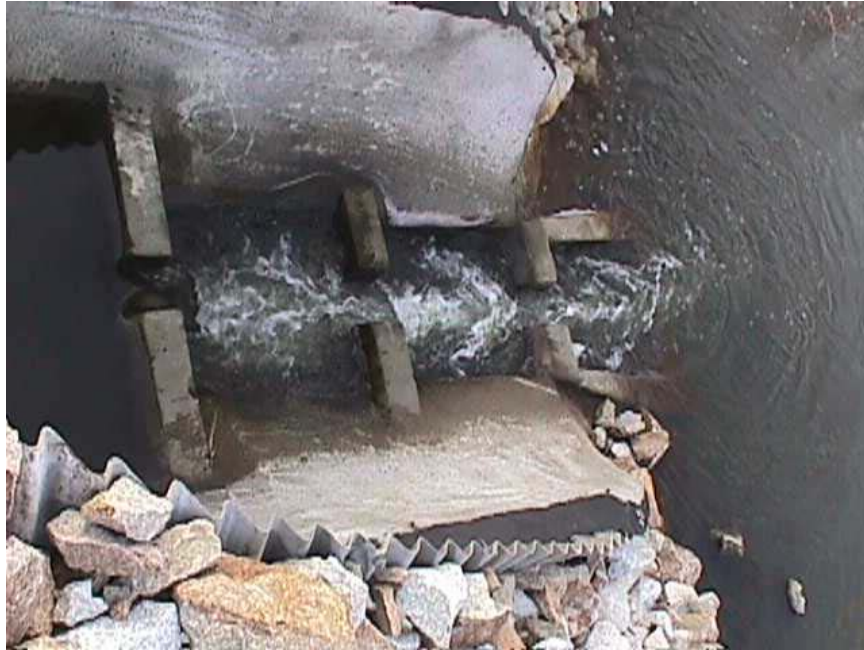
3.1 Fairfield, Fish Brook Bridge # 6218 PIN 011098.00 (Route 104/139 over Fish Brook)

Prior Condition: The preexisting bridge was a 12-ft. diameter steel pipe with heavily rusted bottom and drop at the outlet.

Current Condition: The structure was rehabilitated with concrete invert lining and the addition of in-pipe weirs at the downstream end of the pipe. Construction was completed in fall 2004.

Lessons learned: The designer recommends that the weirs should be spaced further apart on future projects. However, monitoring will need to be conducted to determine the efficacy of the as-built structure.

Future action/monitoring: Post construction monitoring to begin in 2005. Proposed monitoring includes mark-and-recapture electrofishing surveys in conjunction with MDIFW Region B biologists.

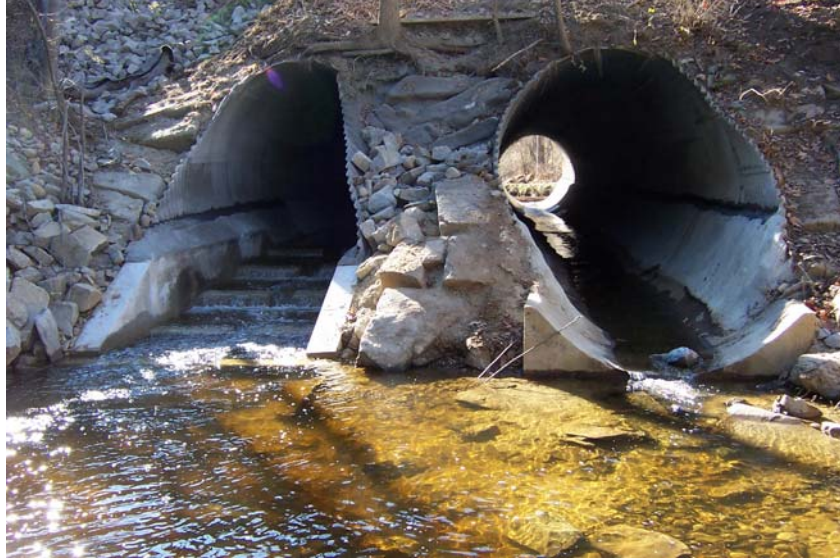
3.2 Westbrook, Mill Brook Hill Bridge #5749, PIN 009031.00 (Austin Street over Mill Brook)

Prior Condition: The preexisting bridge consisted of two 10-ft. diameter steel pipes. The bottom plates were heavily rusted with many holes. The fish passage concern was a small drop at the outlet of the pipes. Due to the high associated utilities costs for a replacement project, culvert rehabilitation with weirs was the selected alternative.

Current Condition: Construction was completed in late fall 2004.

Lessons learned: Excavation for the downstream weirs was difficult due to lack of access for heavy equipment, so the excavation was done by hand with buckets. Constructability needs to be considered during the preliminary design. The contractor could not complete the work within the original instream work window. Future projects with constructability issues should have large enough instream work window to build the project.

Future action/monitoring: Post construction monitoring to begin in 2005. Proposed monitoring includes qualitative observations of use by migrating alewives in conjunction with MDMR fishway counts at the Highland Lake Dam upstream.

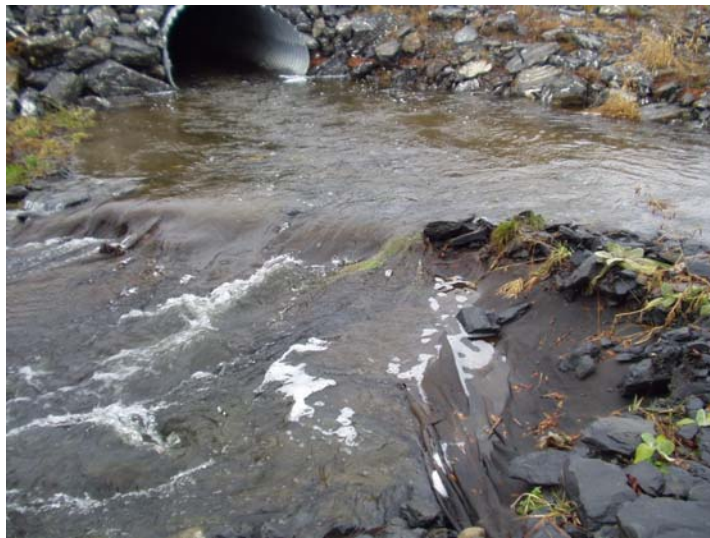
4.1 Wallagrass-Fort Kent, PIN 5220.10, Rt. 11, Pinette Brook (2003)

Prior condition: The preexisting structure consisted of twin 36-in. pipes, 50-ft. long each. The pipes needed replacing because they were too short and too small for the redesign. In addition the area was reviewed for drainage needs and therefore required a larger diameter to meet modern standards.

Current condition: Installed a new 7-ft. x 40-in. structural pipe plate arch, approximately 95 ft. long, with approximately 6-8 in. hang at outlet due to shallow ledge. The downstream pool elevation was raised to match culvert elevation by installing a weir of non-woven geotextile fabric and rip rap in the downstream pool. The stream elevation at outlet of downstream pool was also raised sufficiently to pass fish. However, some rip rap scoured and moved around within the downstream pool, exposing a small area of geotextile fabric, but has not compromised structural integrity of weir.

Future action/monitoring: Will continue to monitor site conditions to ensure weir continues to function as intended and allows fish to pass. Final monitoring to occur in 2005.

Lessons learned: Use larger rip rap or install a more permanent structure such as concrete Jersey barrier weir.

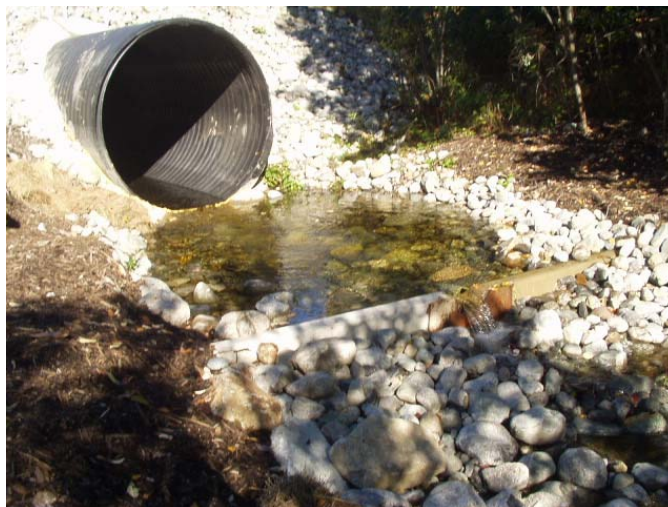
4.3 Carrabassett Valley, PIN 10803.00, Rt. 16/27, Unnamed Tributary to Carrabassett River (2003)

Prior condition: The preexisting structure was an 84-in. multiplate corrugated pipe. The pipe was in poor condition with holes at and below the waterline. In addition, there was a 6-in. vertical drop at the outlet. The structure is located 60 ft. upstream of the confluence with South Branch Carrabassett River, 2.1 miles north of the Kingfield town line (adjacent to northern boundary of the MaineDOT Rest Area). Larger flows are under hydrologic control of Carrabassett River (backwater condition). Substrates predominantly sand and pea-sized gravel upstream, hand-to-head-sized cobble downstream. There is some minor undercutting upstream. Two remnant and one active beaver dam are located upstream. No fisheries issues were identified by MDIFW regional staff; therefore, the site was chosen as experimental location to expand brook trout habitat from Carrabassett River.

Current condition: The structure was rehabilitated with a grouted plastic slip liner with smooth interior, with a downstream pool/weir at the outlet. The weir consists of a flat-bottomed v-notch weir (6 in.) constructed of two concrete Jersey barriers, connected by reinforced concrete, and embedded 3 ft. into stream bank above the normal water line. It was also set a minimum of 2 ft. into the substrate. Stone channel protection and drop-pools downstream of weir outlet. The weir was structurally sound,

with the notch drop approximately equal to that of the outlet. The northwest side of the structure has settled approximately 1.5 in., allowing overtopping flow at moderate discharge levels. The downstream drop-pools were in fair condition. During two post-construction site visits, the rocks forming the pools were relocated to improve the pool configuration.

Lessons learned: In coarse bed materials, bedding of weir structure with finer graded material may be necessary. Compacting bedding material should be standard procedure.

Future action/monitoring: Post construction monitoring through 2005, including brook trout use of upstream habitat.

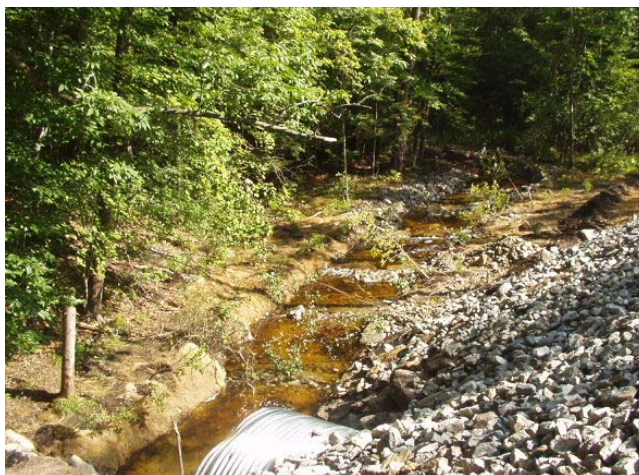
4.4 Sebago, PIN 10802.00, Rt. 11/114, Bachelder Brook (2003)

Prior condition: The preexisting structure consisted of a granite box culvert with outlet baffle sluice which was not maintained and was not effective. The invert elevation was approximately 2 ft. above the normal high water mark of Sebago Lake. The new road design shortened the radius of the road curve; therefore, the stream channel needed to be relocated. The proposed design called for a relocation of a portion of brook, and the installation of four log drop weirs (riffle-pool) to allow fish passage and as grade control for flows in the shortened channel.

Current condition: A new 9-ft. diameter corrugated aluminum pipe was embedded (after removing ledge) at 1 ft. below the normal high water mark of Sebago Lake. The final design substituted granite weirs for log drop structures to reuse material from demolition of granite box and reduce future maintenance needs. New culvert designed with 3% gradient. Slightly more ledge removed during construction than anticipated resulting in 2.5% gradient; therefore, the new channel was graded to match. Lower inlet invert required two additional weirs, for a total of six weirs upstream. The riparian zone between the new channel and roadway toe-of-slope was re-vegetated with variety of plants for future channel shading. The new channel was currently stable after several rain events and high flows

including a $Q_{1.5}$ event on 10/28/03. The channel is evolving as sediment loads from upstream areas migrate through system, changing pool and riffle depths as channel moves towards equilibrium. Brook trout were observed in the new channel.

Future action/monitoring: Monitoring through 2005 will include observation of channel evolution and potential for brook trout and/or adult smelt migration to upstream habitat.

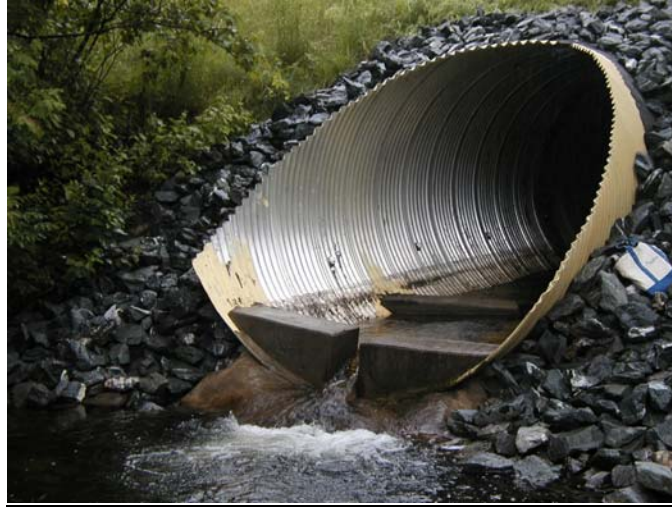
4.5 Linneus, Bither Brook Bridge #3709, PIN 10049.00, Rt. 2A over Bither Brook (2003)

Prior Condition: The preexisting structure was a 103-ft. long, 9-ft. diameter steel pipe with 0.4% slope. The bottom of the pipe was heavily rusted with some holes. There was inadequate water depth inside the pipe during summer and an approximately 6 in. drop at the outlet.

Current Condition: The pipe was sliplined with an 8-ft. diameter aluminum pipe. Concrete weirs and baffles were added inside the pipe to insure adequate depth of water. Two log drop grade control structures were installed downstream to eliminate the drop at the outlet.

Lessons learned: Need to monitor the downstream weirs. The stream may try and create a new low flow channel around the weirs in the long term. The notch in the log weirs was cut narrower than what was shown on the design plans. Future monitoring may indicate a need to adjust the weir opening.

Future action/monitoring: Post construction monitoring until 2005. Additional weir may need to be created downstream of the existing weir to accommodate sheet flow conditions over culvert apron.

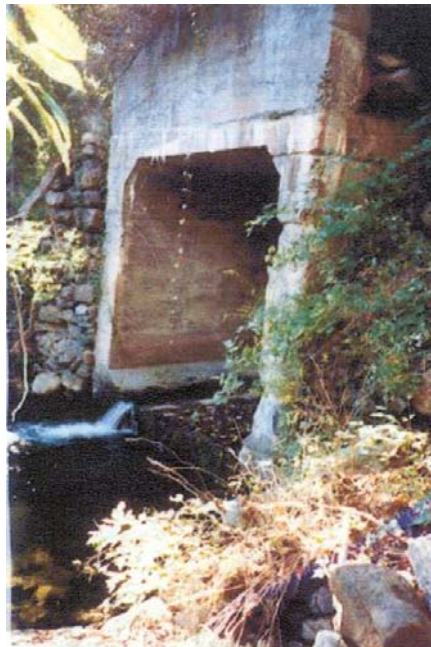
6.1 Camden, Spring Brook Bridge, PIN 010128.00

Existing condition: This project was originally slated as concrete box culvert rehabilitation. Existing concrete bottom slab was to be raised by addition of new concrete. Fish passage concerns were due to the lack of adequate depth and a hanging outlet. The possibility of adding weirs was also considered. The regulatory agencies requested additional grade control structures outside the right of way limits due to shallow flow over some ledges. This area of shallow flow downstream from the bridge would prevent fish from getting to the bridge. Because transportation funds can not be used for structures outside the right of way, the decision was made to change the project scope and not rehabilitate the bottom slab.

Future action: Project scope was changed to eliminate all instream work. The current scope includes slope stabilization and new headwalls.

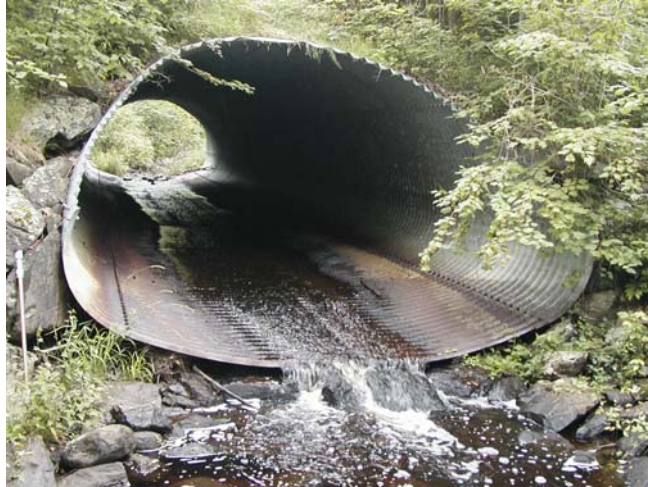
6.2 Eddington, Grant Bridge # 5414, PIN 011094.00 (Route 178 over Meadow Brook)

Existing condition: The existing bridge is single 17'-0" span by 11'-2" rise by 96' long steel structural plate pipe arch built in 1975. The pipe arch is in poor condition with heavily rusted bottom plates and some holes through the bottom plates. The pipe arch had inadequate water depth inside during summer and an approximately 1-ft. drop at the outlet.

Future action: Proposed project is concrete invert lining with six additional concrete weirs. Five weirs will be constructed inside downstream end of pipe arch to form series of 6' by 6' pools. The remaining weir will be located outside the pipe. No weirs or grade control structures will be used outside of the pipe arch. The project was advertised in February 2005 with construction to be completed by fall 2005.
